## Tip: Strange Happenings Log Part 3

### 39970 Fixed Function Decoder Address 71 Fails

### 2271 Points and 2275 Double Slips are 30 Years Old

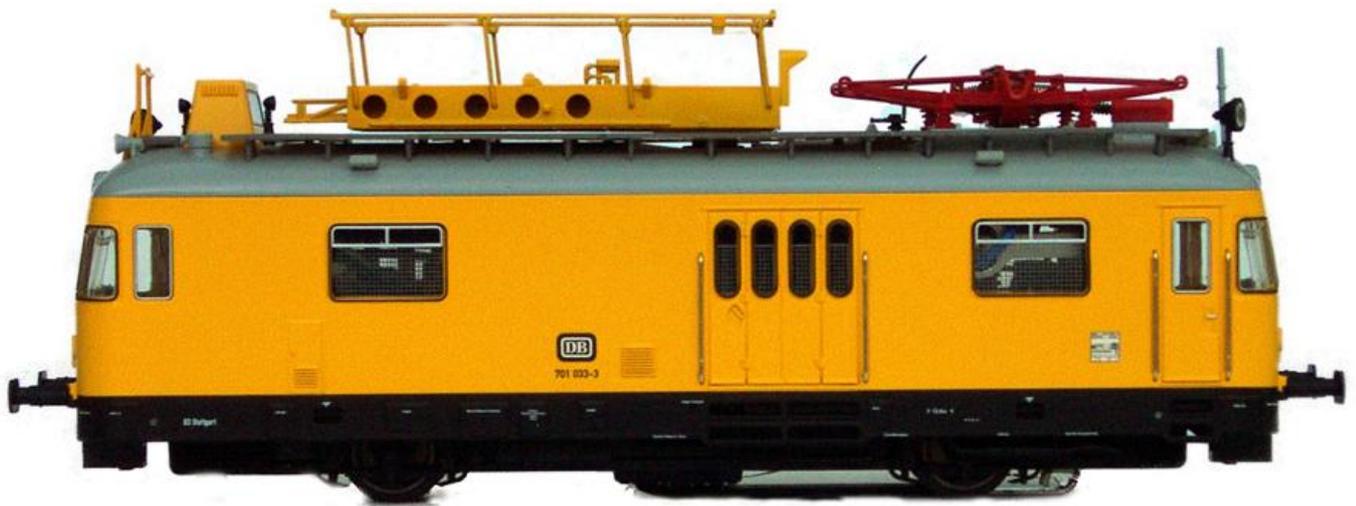
**23-08-2019** After 11 years my 39970 Catenary Maintenance Car platform and pantograph functions failed to function.

**Problem search:** - When I removed the locomotive body shell the pantograph released to the raised position. With the body shell removed I did a power reset of the locomotive and noted the pantograph Piezo motor initialized, this was an indication that all the Piezo motors may still be in working order. My first thought was that somehow the decoder address wasn't responding to the fixed decoder address **71**.

**Solution:** - I remember I read somewhere that the fixed address **71** had changed somehow even though it isn't supposed to be programmable. I first had a look at [Stummis Model Rail Forum](#) and searched for **39970** and found 129 results. A lot of forum entries advised to select a new Motorola address on the central unit. This is a random process as I selected a new address then the manual Piezo motor initialization **F4** function button is turned on for a short period and observed if there was any movement of the locomotive platform.

I started at address **1** and finally noticed platform movement at address **28**. With the new address I had full control of the platform up/down (**F1**), platform rotation CW/CCW (**F2**) and pantograph up/down (**F3**). I was once again happy to see my Catenary Maintenance Car operate.

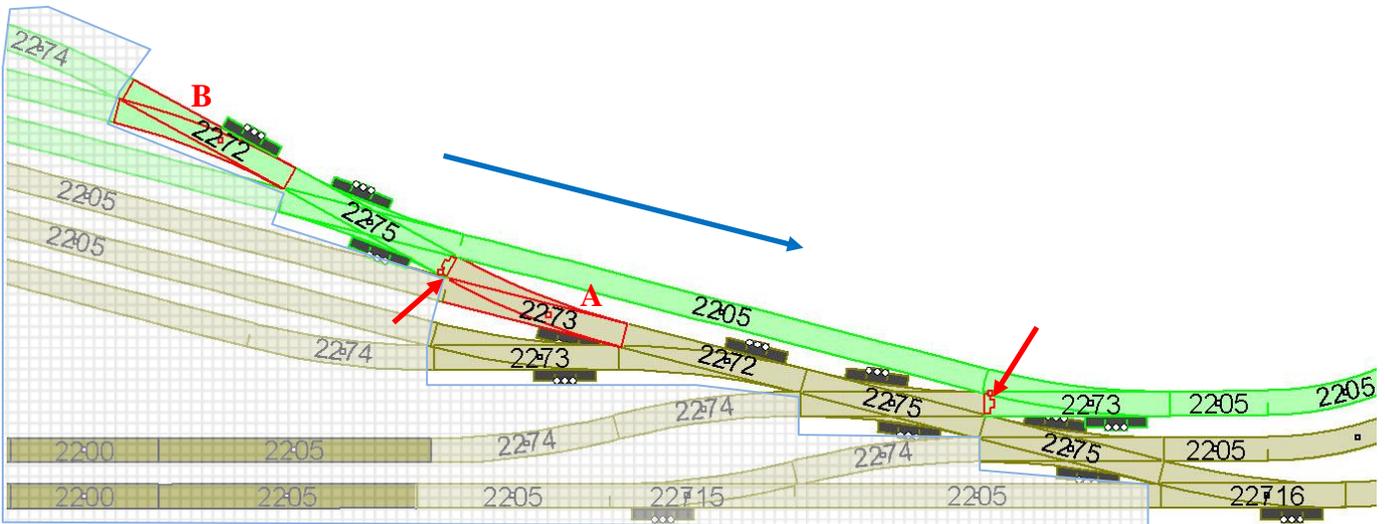
30-09-2018 **Problem 1:** - As stated above my layout is showing its age where I'm reaching the mean time for failures of items on my layout. A right hand trailing point marked (A) 2273 failed two years ago and a leading point 2272 marked (B) failed 3 weeks ago.

Anyone that has used k-track will know that replacing bad track pieces isn't simple as you have to unscrew a certain amount of surrounding track to be able to remove and replace the offending pieces. To make things more difficult the track required centre rail insulators at the red arrow locations for two electrical circuits.

As point (A) is a trailing point I put up with not being able to switch it and decommissioned it within TrainController so I could still run my trains but with the failure of point (B) a leading point it was time to replace the non operating points to gain full control of the layout once more.

I decided all track shown cross hatched would remain fixed and the rest of the track would be removed in the direction of the blue arrow.

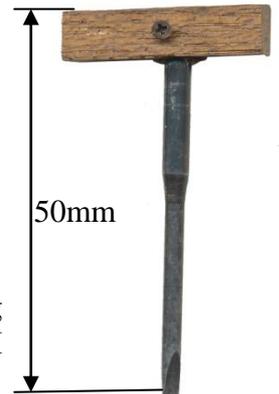
**Problem 2:** - A standard jeweller's screwdriver was too tall for the limited space I had to work in. To overcome this problem I used the removable driver bit and inserted it into a 3mm hole drilled into a small wood handle (25x6x6mm). The screwdriver bit was held in place with a track screw that came in contact with the flat tapered fixing section of the bit.

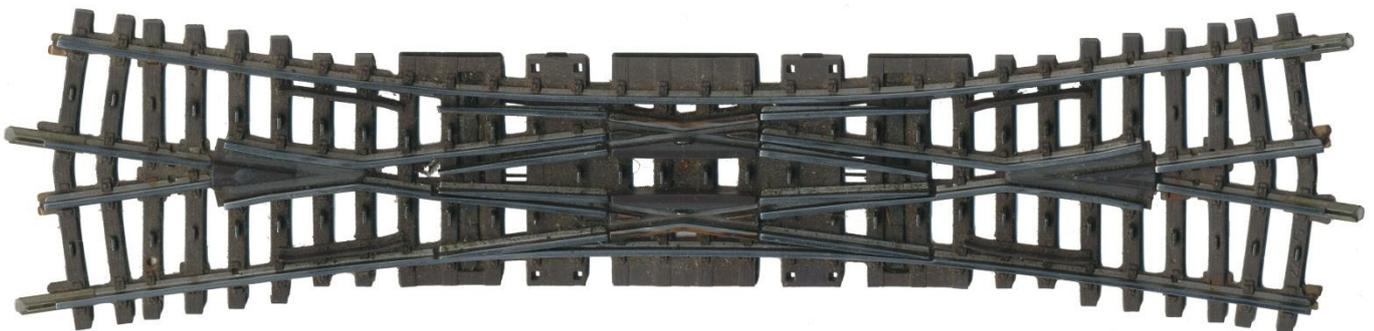
After 30 years of use I found all the points remarkably clean with only a little dust and very little grease/oil contamination, bearing in mind I have never cleaned the track in this area of the layout. The example above was the dirtiest of the lot so zoom in for a closer inspection.

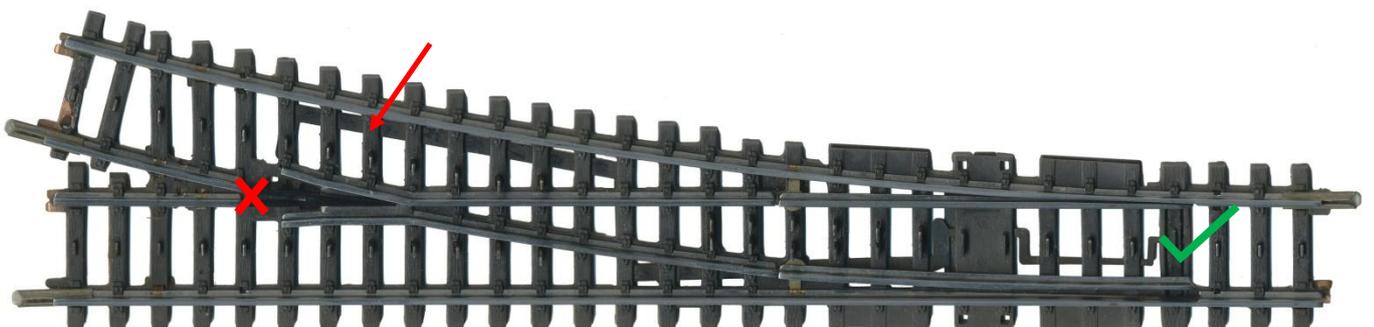
For point (A) I found the moving frog (**X**) was jammed and the moving point blade worked.

Problem area shown with red arrow but it isn't visible from the top view.

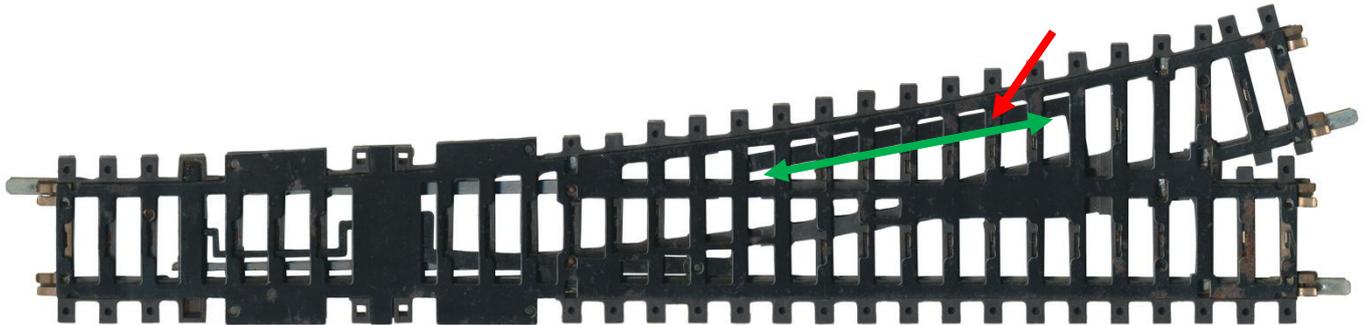
Point (A) continued

Having a close look at the bottom of the point I found the centre rail material was squeezed in, pinching the plastic actuator at the red arrow which prevented movement in the direction of the green arrow. I can't explain why it worked for many years.

**Solution Point (A):** - I used a small screwdriver and straightened the metal at the point of the red arrow. Now the point works perfectly.

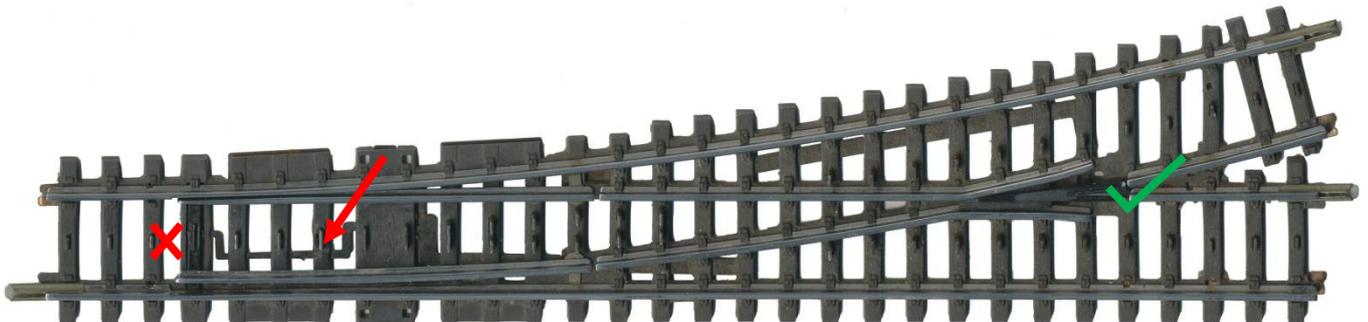
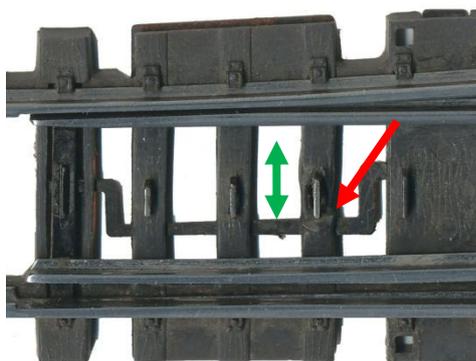
For point (B) I found the moving frog worked and the moving point blade was jammed.

On close examination of point (B) I found that the track sleeper had melted the plastic around the centre rail which had closed the gap to allow free movement of the point blade actuator in the direction of the green arrow.

At some stage I must have had a derailment at this location where the collector shoe of a locomotive caused this damage.

**Solution Point (B):** - I used a flat bladed screwdriver and increased the gap around the point blade actuator to allow free movement. Now the point works perfectly.
