## Tip: Strange Happenings Log Part 3

### 39970 Fixed Function Decoder Address 71 Fails

### 2271 Points and 2275 Double Slips are 30 Years Old

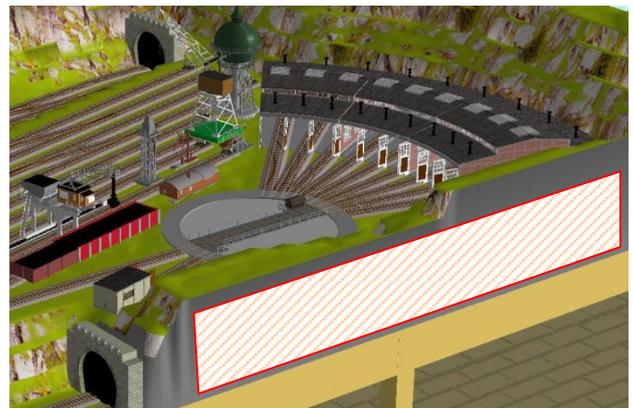
30-09-2018 **Problem 1:** - As stated above my layout is showing its age where I'm reaching the mean time for failures of items on my layout. A right hand trailing point marked (A) 2273 failed two years ago and a leading point 2272 marked (B) failed 3 weeks ago.

As point (A) is a trailing point I put up with not being able to switch it and decommissioned it within TrainController so I could still run my trains but with the failure of point (B) a leading point it was time to replace the non operating points to gain full control of the layout once more.

Anyone that has used k-track will know that replacing bad track pieces isn't simple as you have to unscrew a certain amount of surrounding track to be able to remove and replace the offending pieces. To make things more difficult the track required centre rail insulators at the red arrow locations for two electrical circuits.

I decided all track shown cross hatched would remain fixed and the rest of the track would be removed in the direction of the blue arrow.

Access was from the side of the layout with only 80mm height below the Catenary. To aid in access the turntable was removed.
